Simple

FAA

STORY BY **GLEN WHITE**
PHOTOS COURTESY
FAA & NTSB

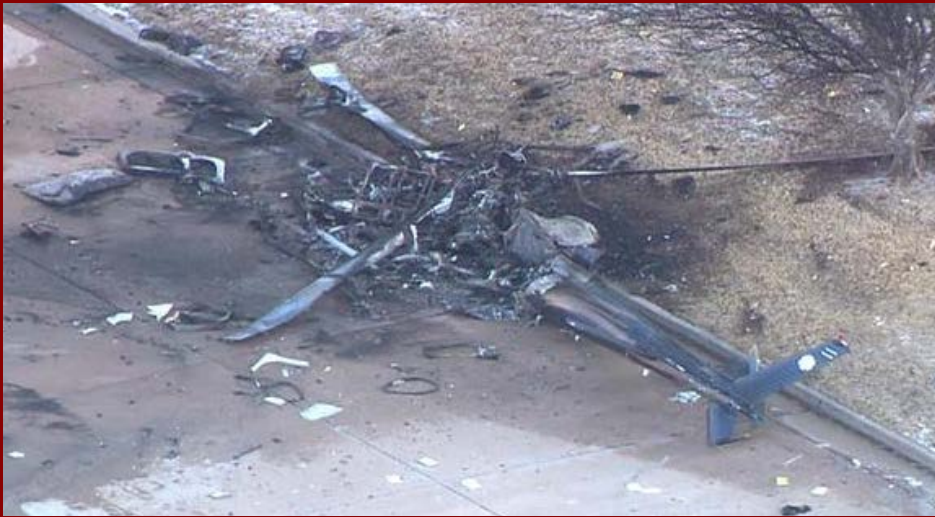
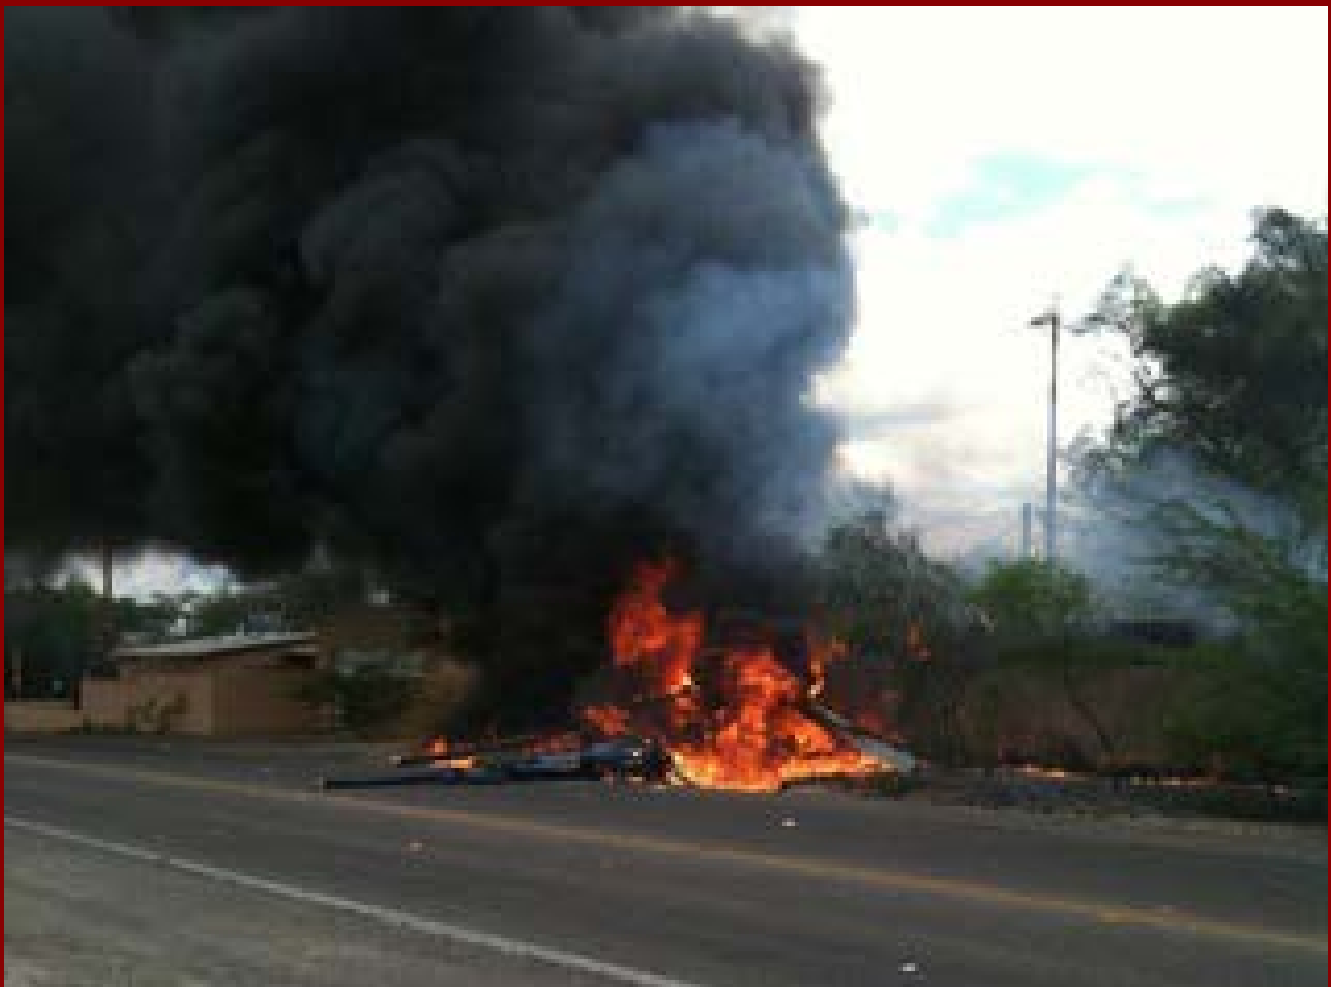
There is no way to know if the pilot established the proper collective position/rotor RPM and or airspeed during the entry in to the autorotation. The only clue into the stability of the autorotation is a photo that was taken by a witness. It shows the helicopter at approximately 300-400 feet above the ground in a near vertical descent. This would have been halfway from engine failure to ground contact. The question then is “why did the pilot find it necessary to place the helicopter in this flight profile”?

The normal steady state autorotation in an AS350 is a near level to slightly nose down attitude when the airspeed is properly set and the rotor RPM is in the green. Assuming that the pilot was reacting properly to an abnormality in the autorotational profile the only reason to place the helicopter in this attitude would have been a severe loss in airspeed. With the decrease in altitude it would have taken from powered flight to the profile depicted in the photo, a conclusion could be made that airspeed was lost in the entry and the required correction was a very nose down attitude.

With the helicopter in the attitude depicted in the photo the location of the inevitable landing would be directly in front of the helicopter. At this point the helicopter was located approximately over North Tyndall Ave, with an approximate heading of 132°.
