Simple

FAA

STORY BY **GLEN WHITE**
PHOTOS COURTESY
FAA & NTSB

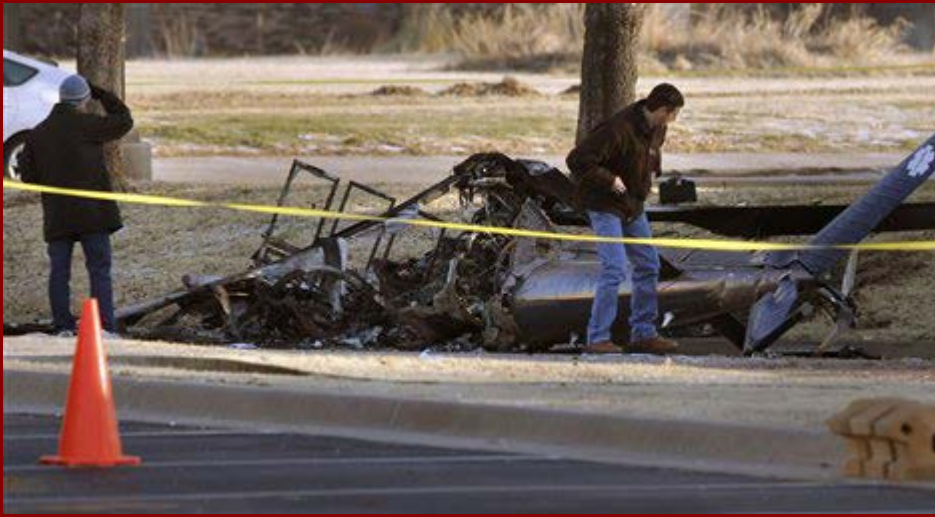
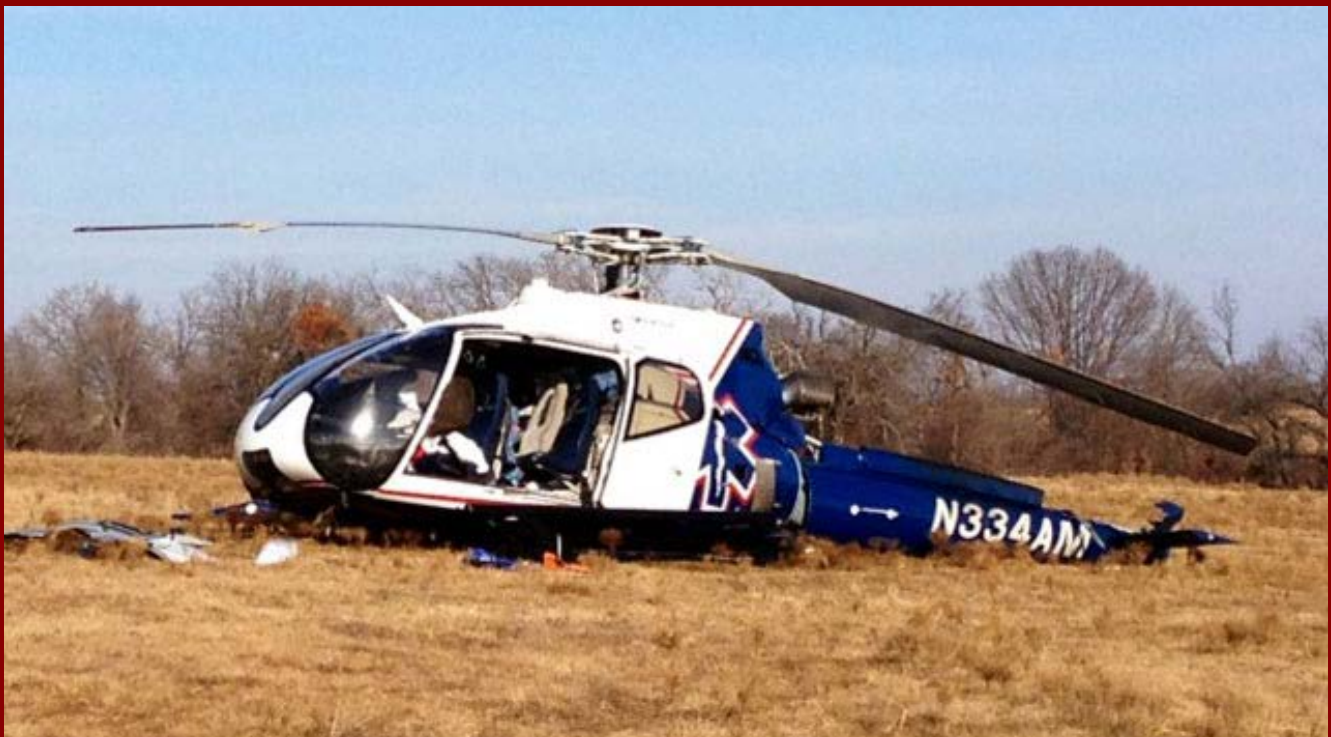
The AS350 is an excellent EMS platform for the transportation of critical care patients but provides little comfort for the medical crew in the back of the helicopter. Between the crew, medical equipment, monitor and patient one feels as if they there are being enveloped by the airframe instead of sitting in the seat of an aircraft.

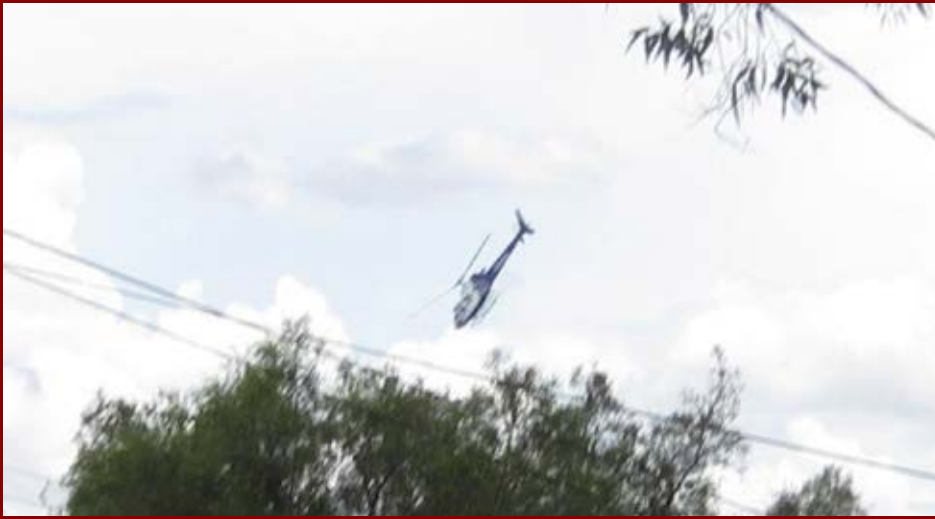
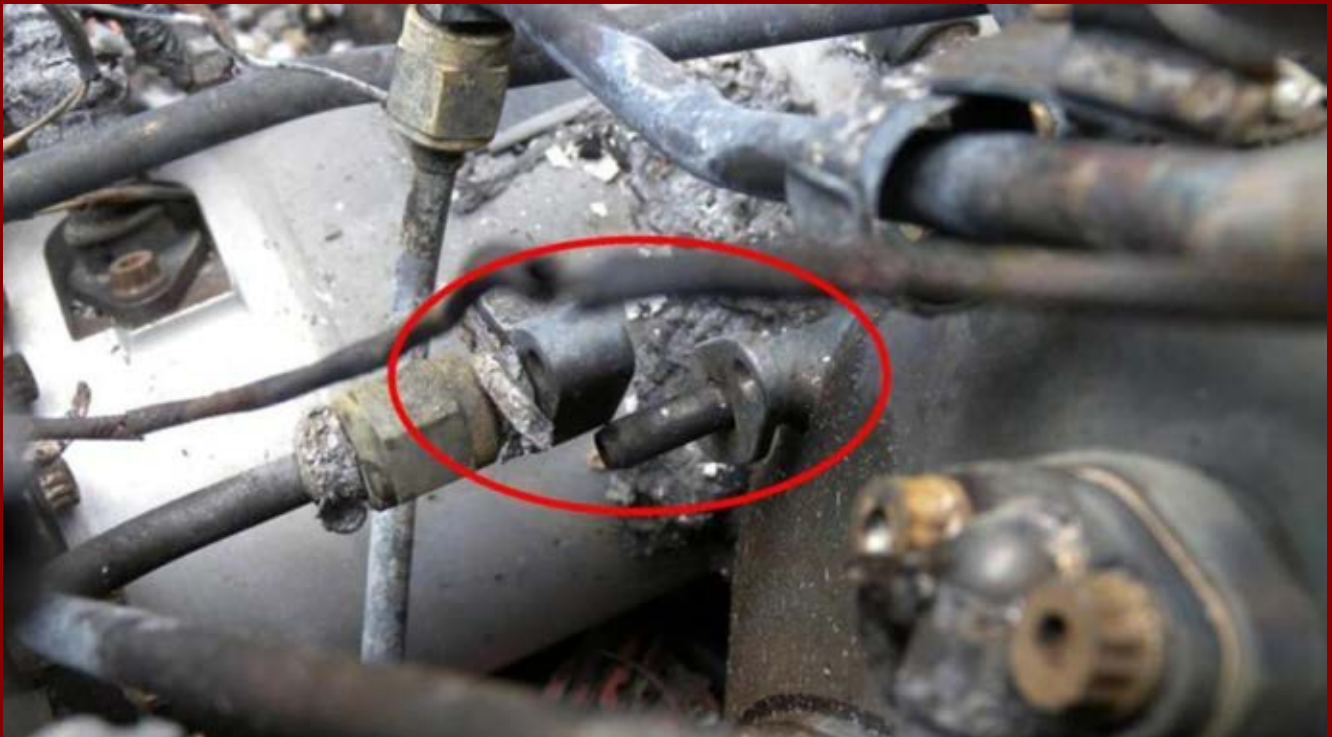
The day prior to the accident, work on the aircrafts' engine was complete, and the powerplant was re-installed on the helicopter. The maintenance action needed on the engine required a Level 3 maintenance event. Since the mechanics at Marana were authorized to perform up to a level 2 maintenance action, a Turbomeca approved outside contractor was brought in. The outside contracted mechanic had worked for Turbomeca for 23 years and had been performing level three maintenance for 12 years.
